## Deformation Monitoring and Analysis of Structures Using Laser Scanners

Dr Gethin Roberts and Laura Hirst

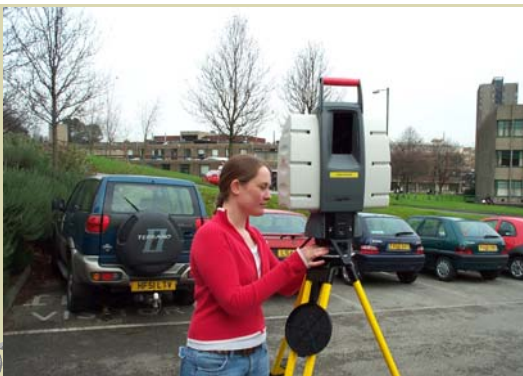
## IESSG building scan

- Building scan used to acquaint users with scanner
- Three scans registered using 4 freestanding HDS targets
- Paper targets used as well as Leica targets
- Paper targets created large errors
- Targets used in front and behind glass, no difference in results
- Further trials planned to re-scan and compare

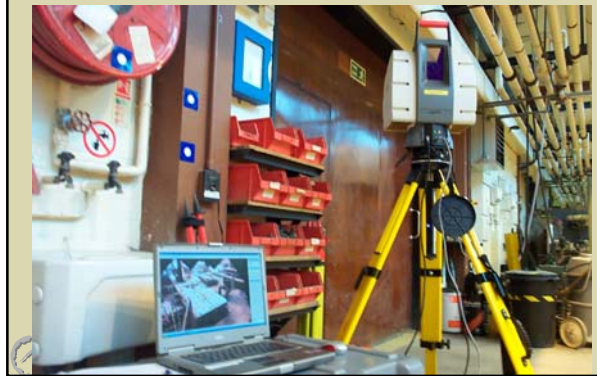
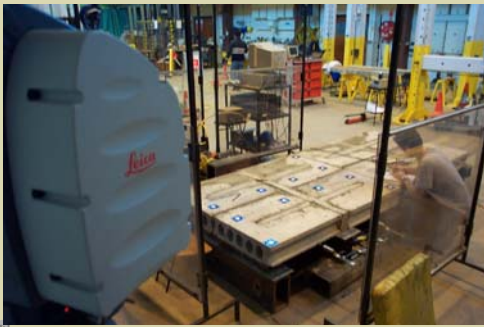
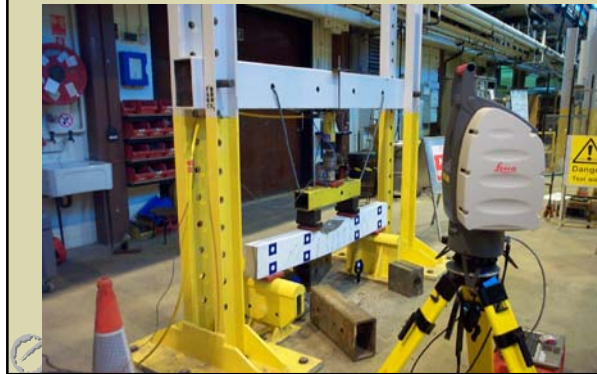
## Beam Cracking

- Beams cracked in the Civil Engineering lab
- Various trials with a variety of beams
- Targets placed on and adjacent to the beams
- Scans taken before and after the beam is deformed
- Leica TCA2003 and TCR705 used to compare results

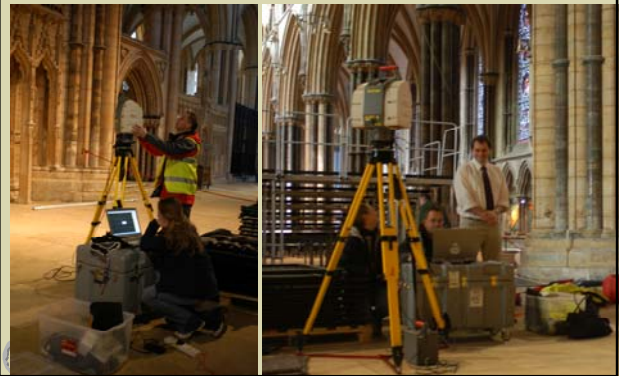
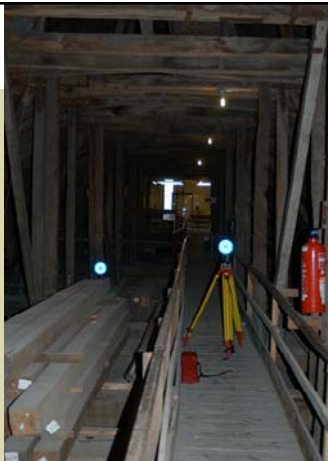
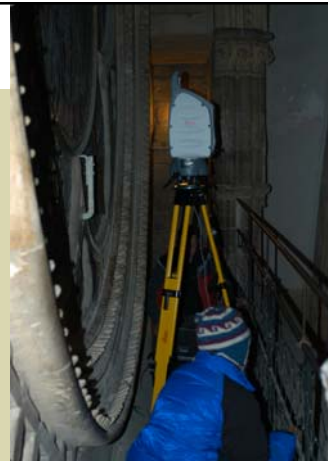
### Lincoln Cathedral indoor

- HDS targets set up within the Cathedral
- Scans taken of the entire space
- Finer scans of stain glass windows and ornamental detail taken
- Targets can not be placed on the walls
- Members of the public have to be watched
- Good results

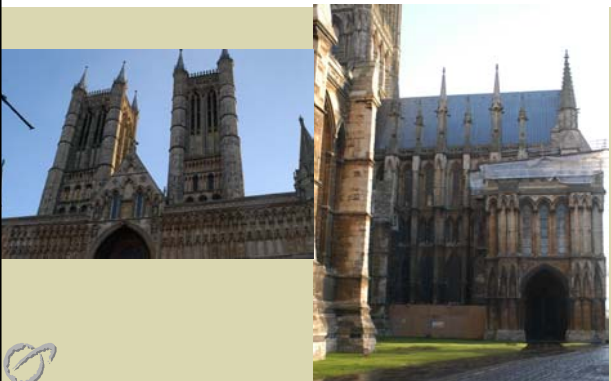
## Lincoln Cathedral outdoor

- Tying the outside scan with the indoor data difficult
- Unique points used rather than HDS
- Targets moved by public etc
- 1mm by 1mm grid of points at approximately 5m would take almost 600 mins
- Material having different resolution in the results, due to strength of signal returned; record of material?
- Wind caused problems
