# **Modern Approaches of Land Parcel Frequent Demarcation of Highly Flooded Prone Zone of Koshi and Kamala River Basin**

**Nabin Kumar SAH , Bishal KHATRI and Subash GHIMIRE, Nepal**

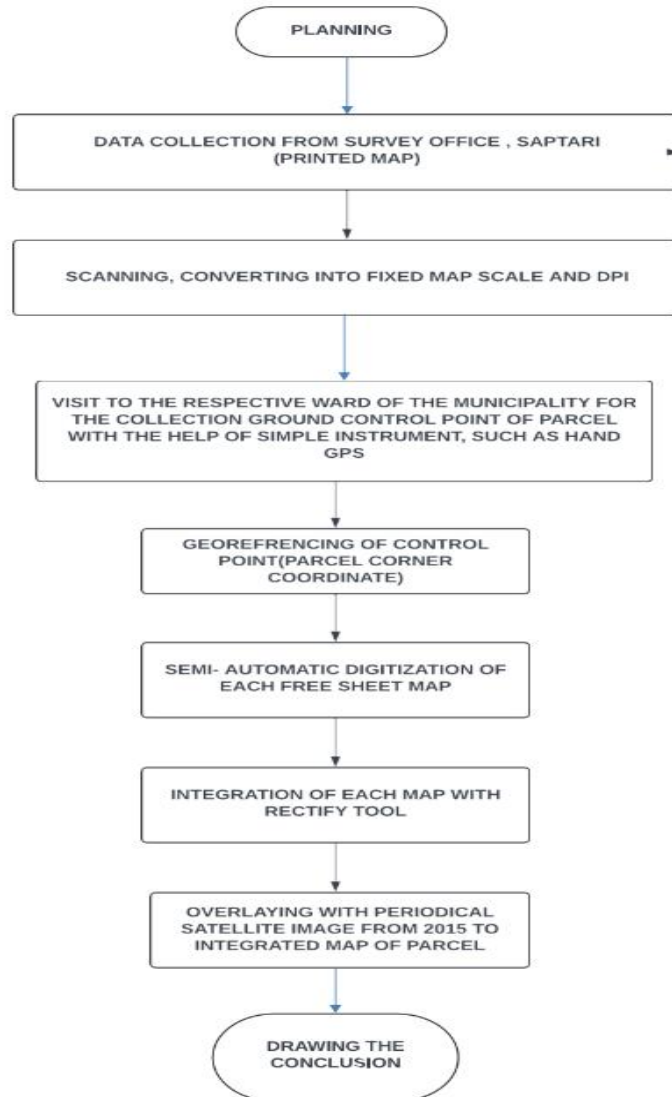
Figure 2: Methodological flowchart

The following is the workflow we followed during our study:

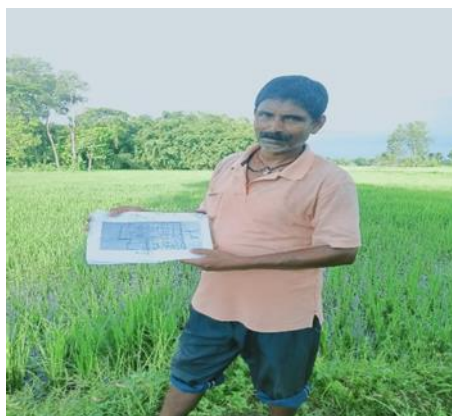
Figure 3: Parcel verification

Satellite images were downloaded from the satellites of google earth, the cadastral map (Free-Sheet) obtain from the respective survey office Saptari, and for geo-referencing, ground-control point of the few parcel (Corner-Coordinates) were observed and taken by the Field Visit, where the data were obtained by simple handheld GPS instrument. The recognition of parcel was done by the respective landowner, who were present in the Cadastral Survey of 2027-2028 B.S.

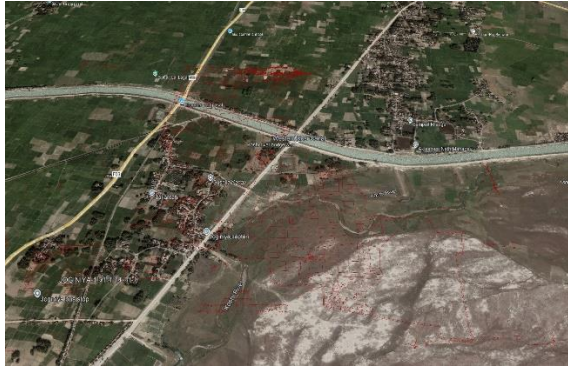
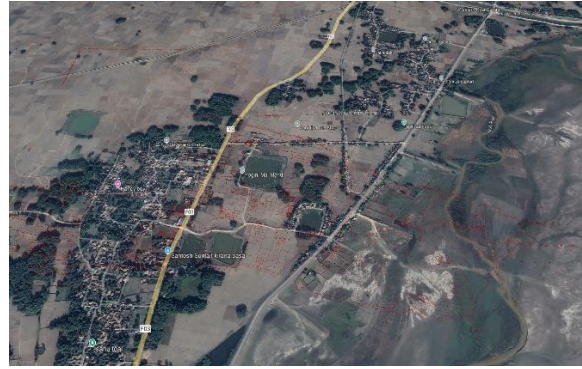
Figure 6: Ward 5 satellite image of 2011-03

Figure 7: Ward 5 satellite image of 2016-12

Figure 8: Ward 5 satellite image of 2017-08

Figure 9: Ward 5 satellite image of 2024-08

The flood prone zone of the parcel being affected by Koshi lies in the east of Koshi Dam(Badh), the Satellite images from 2011-03 to 2024-08, were displayed, the major changes detected were analyzed and the event of major changes in the shapes of parcel were displayed as shown in the figures 6,7,8, and 9. The study shows that the parcel was restored by the personal effort without any survey measurements, which leads to unequal distribution and disputes among the landowners. In 2011, the area was swept out by the flood, the parcel was demarcated and restored in the late years of 2016. Later in 2017, few parcel were swept out by the flood. In present context 2024, maximum no. of parcel being re-stored/ demarcated without the existing demarcation process. The study shows that, these parcel are in the high-vulnerable risk zone of Koshi Flood.

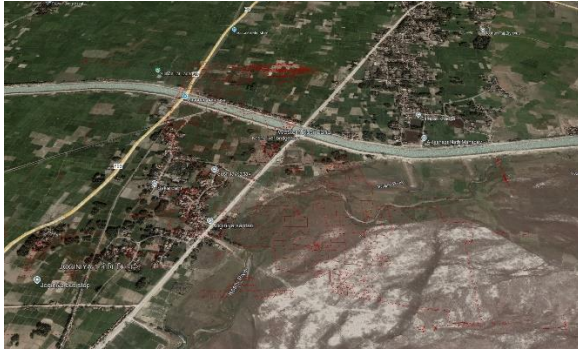
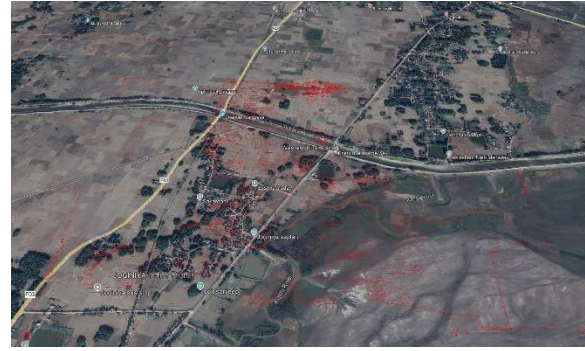
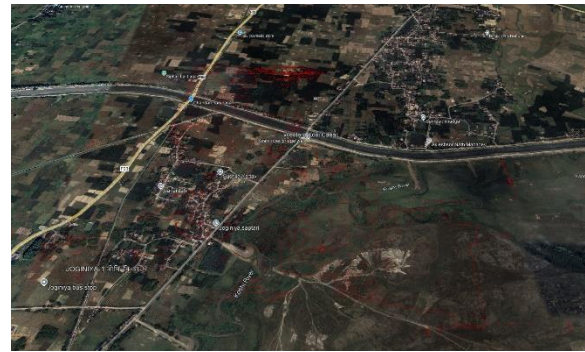
Figure 10: Ward 7 satellite image of 2011-03

Figure 11: Ward 7 satellite image of 2016-12

Figure 12: Ward 7 satellite image of 2017-08

Figure 13: Ward 7 satellite image of 2024-08

The area affected by frequent flood lies in the south of Koshi West-Canal and east of Koshi Dam(Badh), the parcel shape-file is being represented by the red polygon overlaid over the periodical Satellite imagery. The Satellite images from 2011-03 to 2024-08, were displayed, the major changes detected were analyzed and the event of major changes in the shapes of parcel were displayed. The study shows that the parcel was restored by the personal effort without any survey measurements, which leads to unequal distribution and disputes among the landowners. In 2011, the area was swept out by the flood, the parcel was demarcated and restored in the late years of 2016. Later in 2017, few parcel were swept out by the flood. In present context 2024, maximum no. of parcel being re-stored/ demarcated without the existing demarcation process. The study shows that, these parcel are in the high-vulnerable risk zone of Koshi Flood.
