Automated Surface Documentation of Large Water Dams Using Image and Scan Data of Modern Total Stations

Slaven KALENJUK and Werner LIENHART, Austria

FIG Working Week 2017

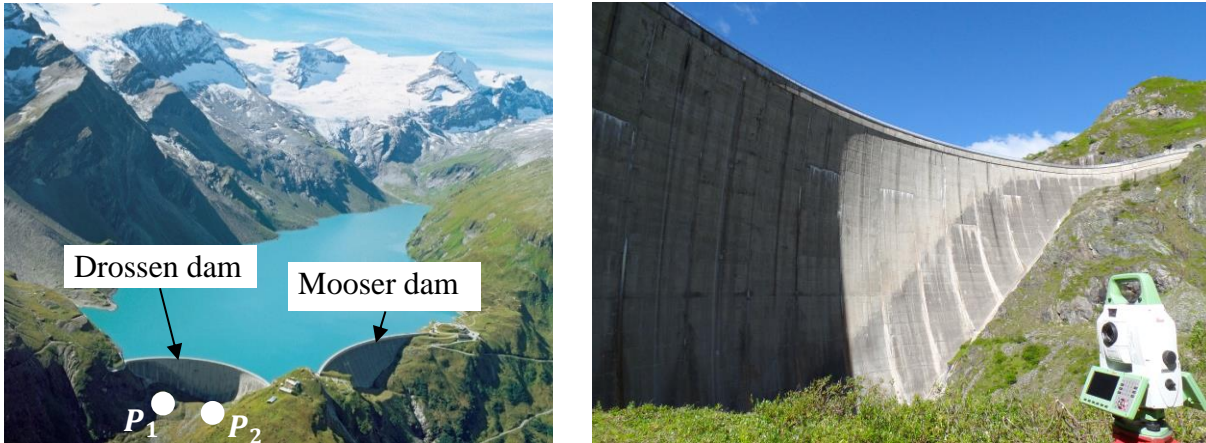
Figure 2: Measurement site, overview image showing the two concrete dams of the reservoir Mooserboden (left, source: Verbund), frontal view on the downstream side of the Drossen dam with the instrument set up at point P_1 (right)

We performed measurements at the Drossen dam, which is located near Kaprun in Salzburg. With a maximal height of 112 m and a crest length of about 360 m, it is one of the largest concrete arch dams in Austria. Together with the Mooser dam, it impounds the Mooserboden reservoir (see Fig 2.).

Due to the large object-to-instrument distances (up to 200 m) and the scan range limitations, at least two setup points were required to cover the full dam. In order to speed up the data acquisition, we decided to use two Multi Stations simultaneously set up at P_1 and P_2 (see Fig. 2 left). We used fix points with known coordinates to reference measurements from both instruments in the national reference system.

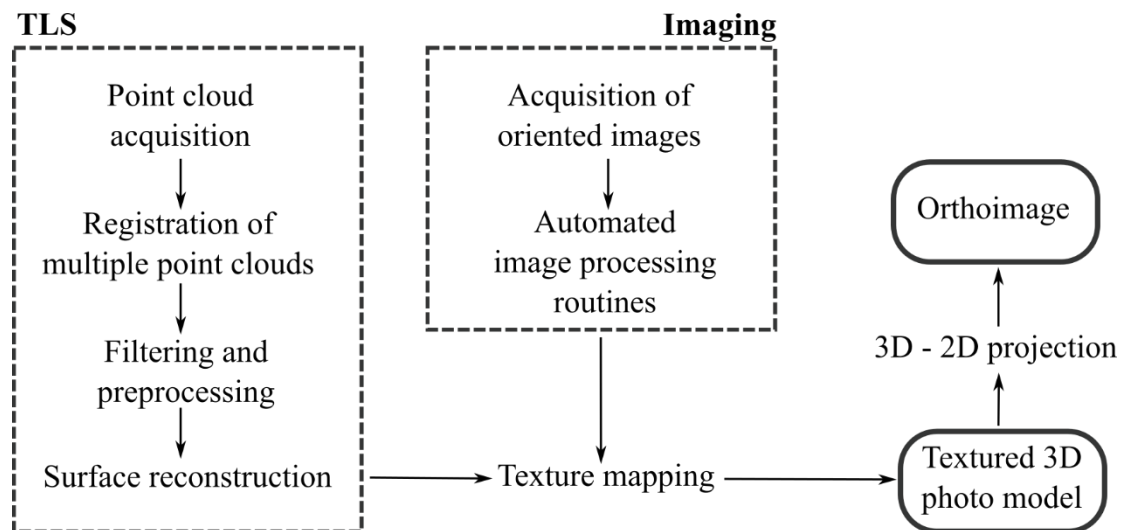
Figure 4: Workflow for deriving textured 3D photo models from scan and image data

The term “surface mapping” refers to the process of combining geometry and texture content of an object’s surface. The principle workflow for processing the acquired scan and image data to derive a textured 3D photo model is illustrated in Fig. 4 and explained below.

TLS data processing consists of point cloud registration, filtering, outlier elimination and hole filling procedures. We then use the modified point cloud to reconstruct a continuous digital representation of the surface with a combined approximation-interpolation method. We partition the data space into voxels, for which we compute characteristic points by averaging the respective points inside. This step provides a simple but effective approximation method and hence noise reduction. Eventually, we use 3D Delaunay triangulation to compute a triangle mesh, i.e. a set of triangles connecting the averaged point cloud.

Dependent on the properties of the captured images, we apply automated image processing techniques to reduce radiometric differences and thus to obtain a homogenous texture.

The camera model (i.e. interior and exterior camera orientation) establishes the spatial reference for projecting the images onto the triangle mesh. Using a Multi Station with a calibrated camera, the surveyor directly obtains photos with orientation parameters. The projection process, also referred to as texture mapping, produces a photo realistic 3D representation of the object, which we then map onto a plane to generate an orthoimage with metric information.

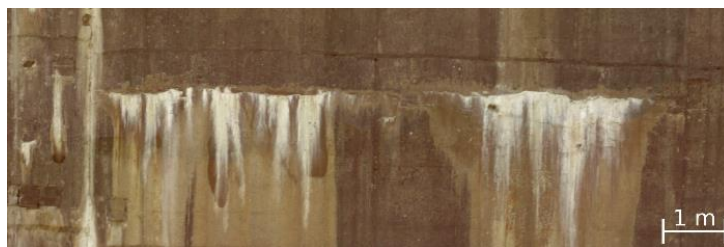
Figure 6: Orthoimage of a defect region on the downstream side of the Drossen dam (block 16), derived from 21 OAC textures (1 pixel corresponds to 2 mm on the surface)

Large civil structures commonly feature some concrete deficiencies, which, in principle, do not necessarily pose a risk to the structure's safety. Therefore, knowledge about the exact crack length and width (e.g. Fig. 6) is not required but detecting any visual changes in the defect region is rather crucial for Structural Health Monitoring (SHM).

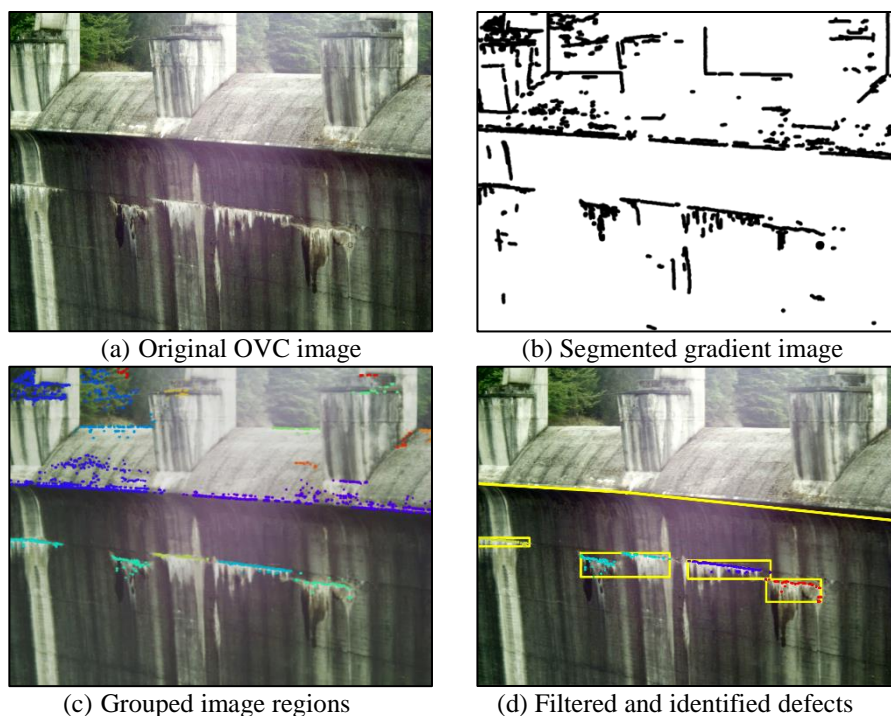
Figure 8: Important steps of the defect detection algorithm

3. **Clustering:** The spatial distribution of the extracted individual pixels defines the criteria to generate coherent pixel clusters (cf. Fig 8c). The algorithm *Density-Based Spatial Clustering of Applications with Noise* (DBSCAN) defines a cluster as a set of pixels, within which the data density is sustainable higher than outside. Ester et al. (1996) suggest a heuristic for the variables in the DBSCAN algorithm.

4. **Spatial Filtering:** The procedure described so far is not able to distinguish between the dam surface and other objects (e.g. vegetation, cf. Fig. 8c upper part). To enhance the detection results, we exploit the known camera model of the Multi Station (cf. Section 2). We transform the discrete points representing the contour line of the dam's surface into the image space. We create a polygon to filter out the clusters, which do not cover the dam (Fig. 8d).

Eventually, we compute the direction to the defects using the pixel coordinates and the known camera model of the representative MBRs (minimum bounding rectangle, see Fig. 8d).
